IN DEPTH INSPECTION REPORT

P.I.N. 3501.60

B.I.N. 1093562

TEAM LEADER	Logan Bessel, P.E.	98781
		NYSPE LICENSE #
ASSISTANT TEAM LEADER	Samantha Lusher	
ASSISTANT TEAM LEADER		
ASSISTANT TEAM LEADER		
FEATURE CARRIED	I-481 Northbound	
FEATURE CROSSED	Manlius Center Road (NYS Route 290)	
DATE FIELD WORK BEGAN	February 7, 2022	
DATE FIELD WORK COMPLETED	February 9, 2022

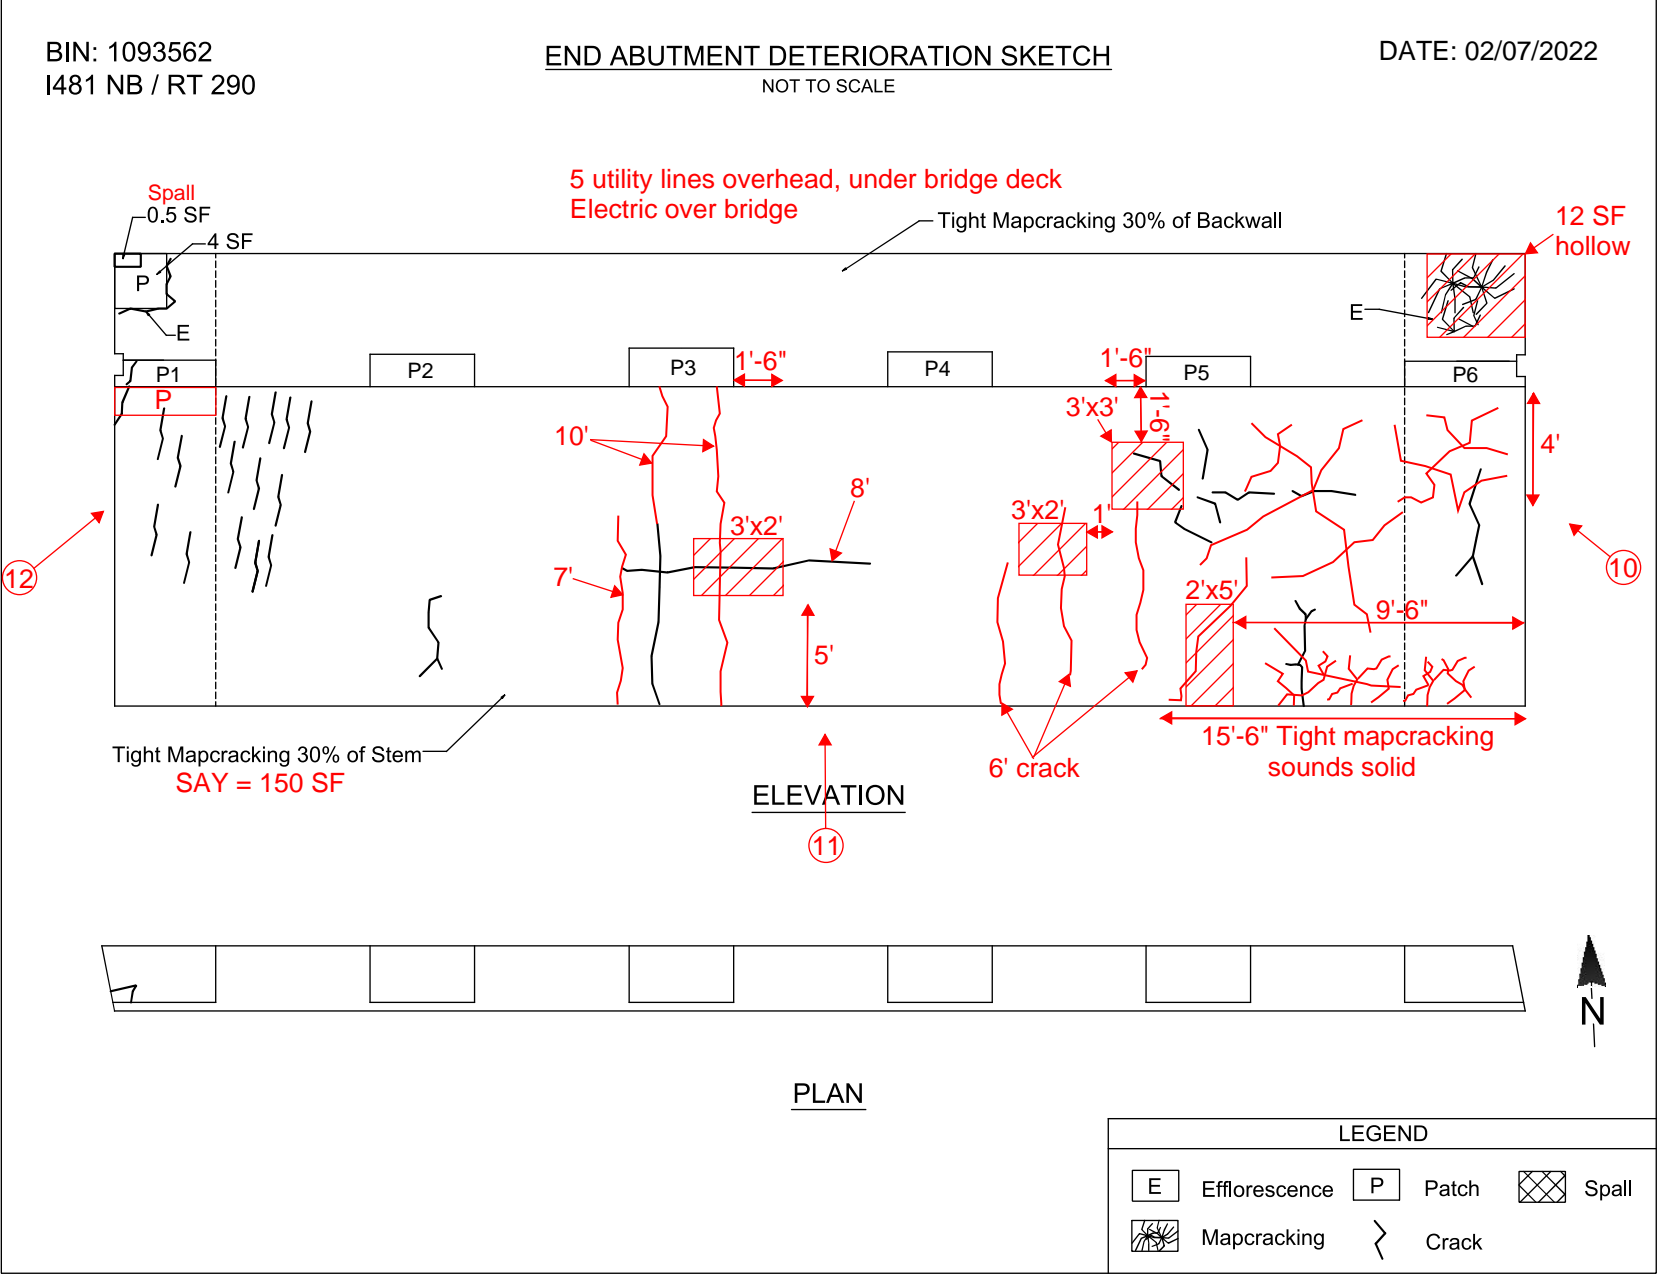
North Abutment – Concrete backwall contained 6” deep spalling above pedestal 1 and delaminated concrete above pedestal 6. The pedestals exhibited cracking, spalling and delaminated concrete. The abutment stem exhibited vertical cracks, areas of map-cracking and delaminated concrete. The wingwalls are 100% map-cracked.

Spall Areas = 0.5 SF

Hollow Areas = 6 SF + 6 SF + 9 SF + 10 SF + 12 SF = 43 SF

Map-Cracked Area = 150 SF + 150 SF = 300 SF

Total Length of Cracks = 7' + 10' + 10' + 8' + 6' + 6' + 6' = 53 LF

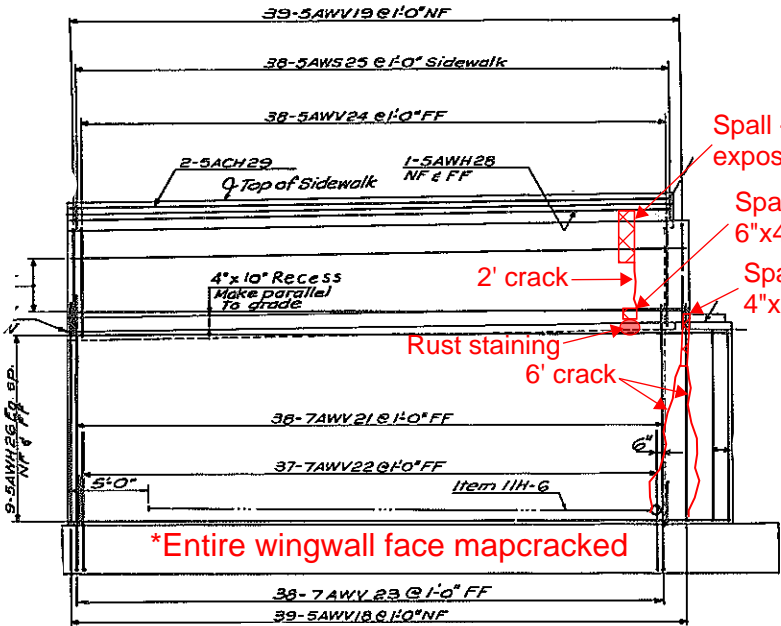
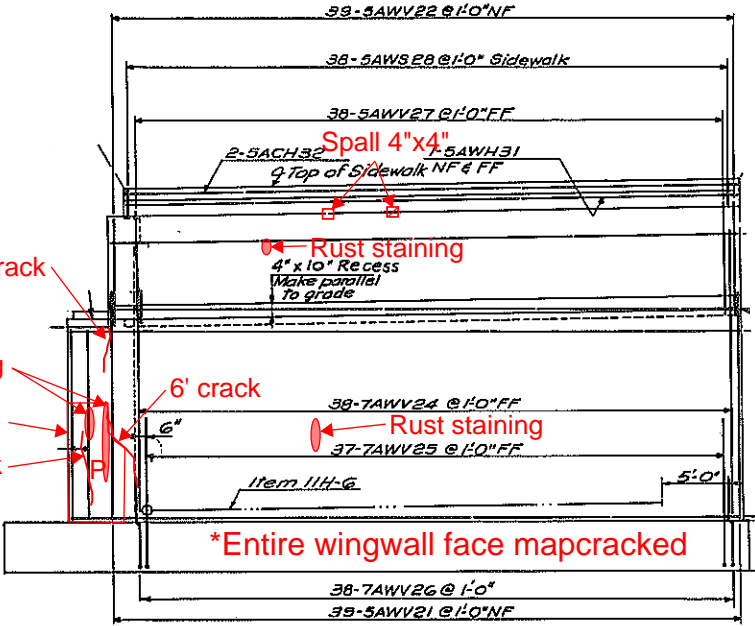
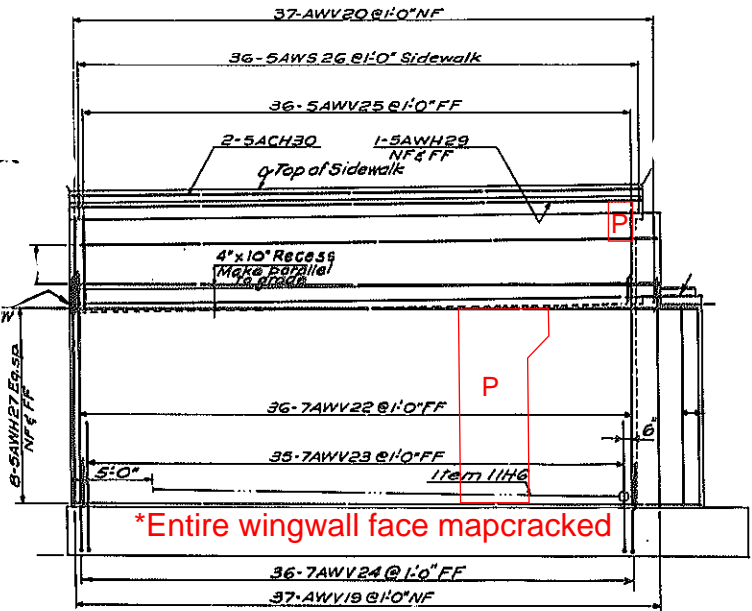
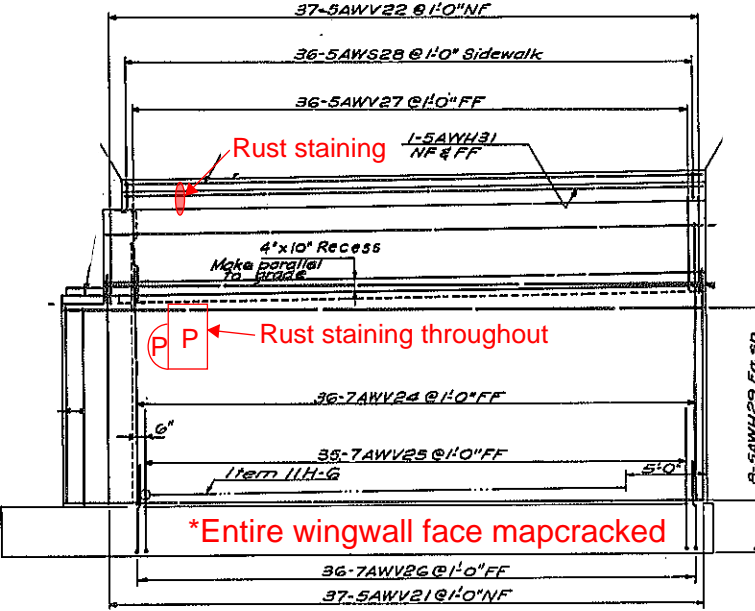
1.481 N.B. & S.B.
OVER S.H. 555
WINGWALLS

Spall Areas = 2.3 SF + 0.2 SF + 1.2 SF + 0.1 SF + 0.1 SF = 3.9 SF

Map-Cracked Area = 35' x (18.37' + 19.39' + 20.03' + 20.06') = 2721.25 SF

Total Length of Cracks = 6' + 6' + 2' + 6' + 4' + 2' + 5' + 6' = 37 LF

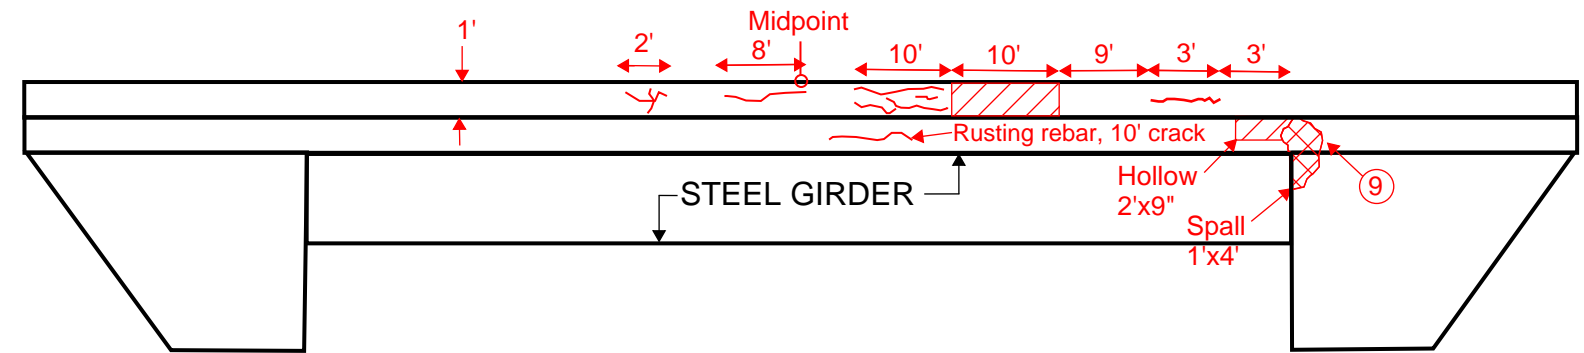
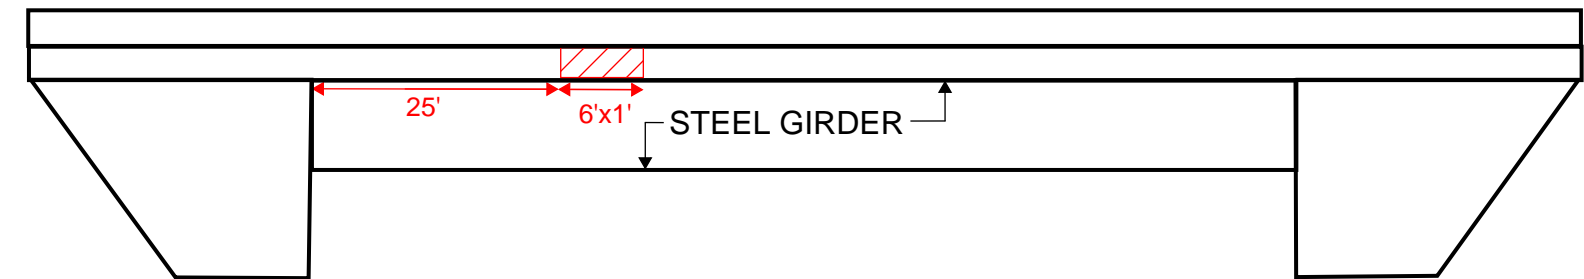
FASCIA ELEVATION VIEW

⑨ Spall in bridge overhang joint

Delaminated Area = 21.5 SF
Spall Areas = 4 SF
Hollow Areas: 10 SF + 1.5 SF + 6 SF = 17.5 SF
Map-Cracked Area = 2 SF + 10 SF = 12 SF
Total Length of Cracks = 8' + 10' + 3' = 21 LF

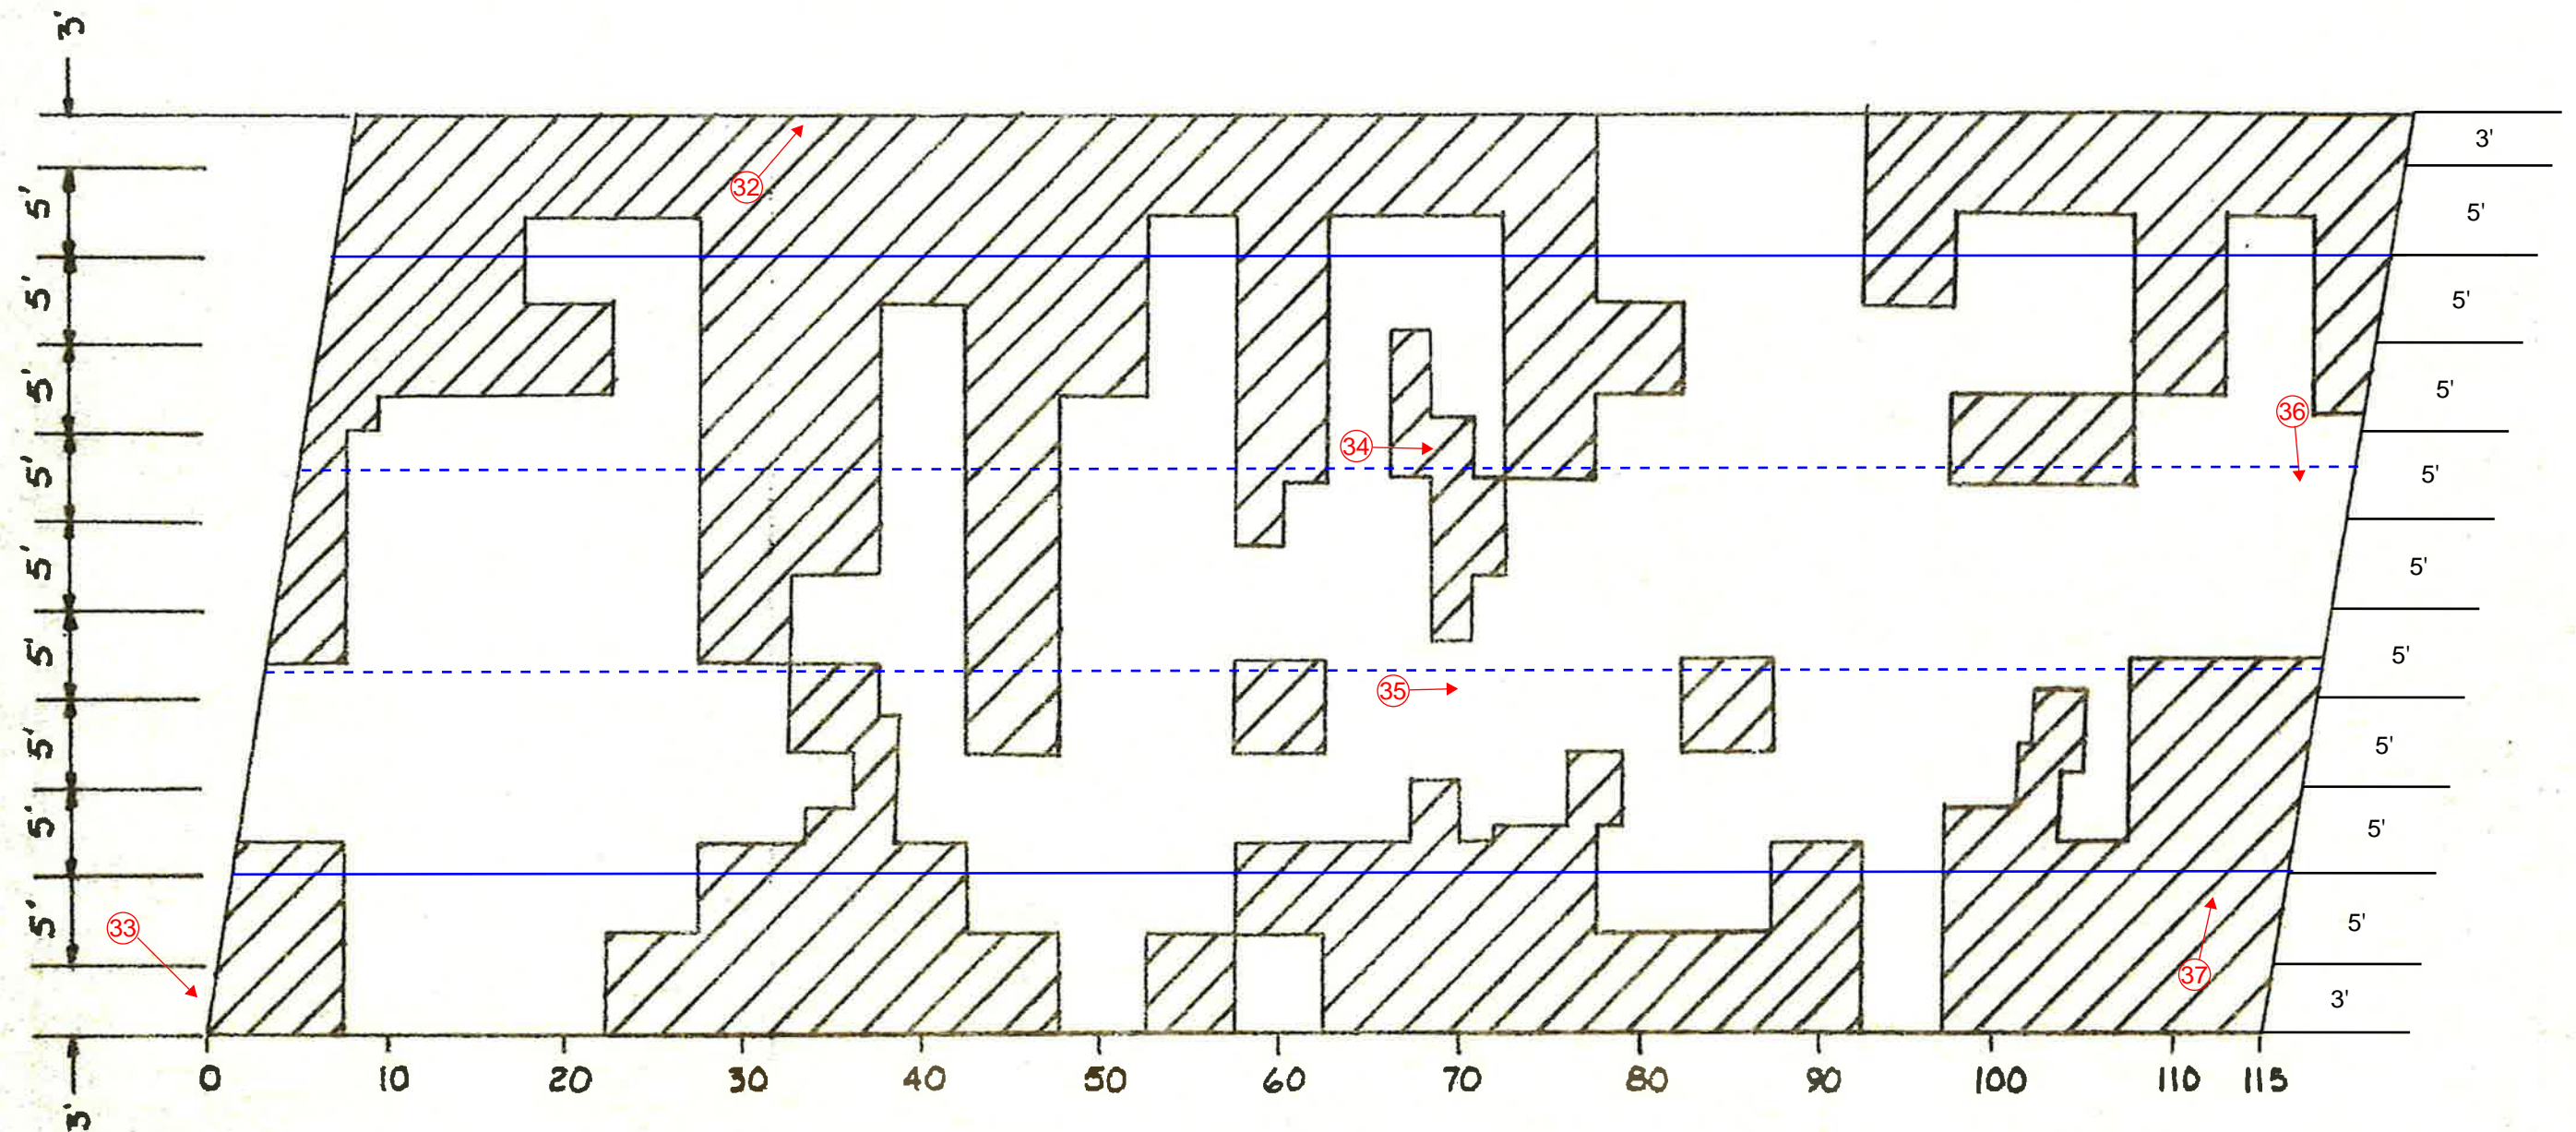
- ③② Bridge deck left guiderail - rusting
- ③③ Begin bridge deck joint - right shoulder - puddling
- ③④ Bridge deck - general view
- ③⑤ Bridge deck - general view
- ③⑥ End bridge joint center lane - cracking through travel lanes to right shoulder
- ③⑦ End bridge joint right shoulder - cracking through travel lanes to right shoulder

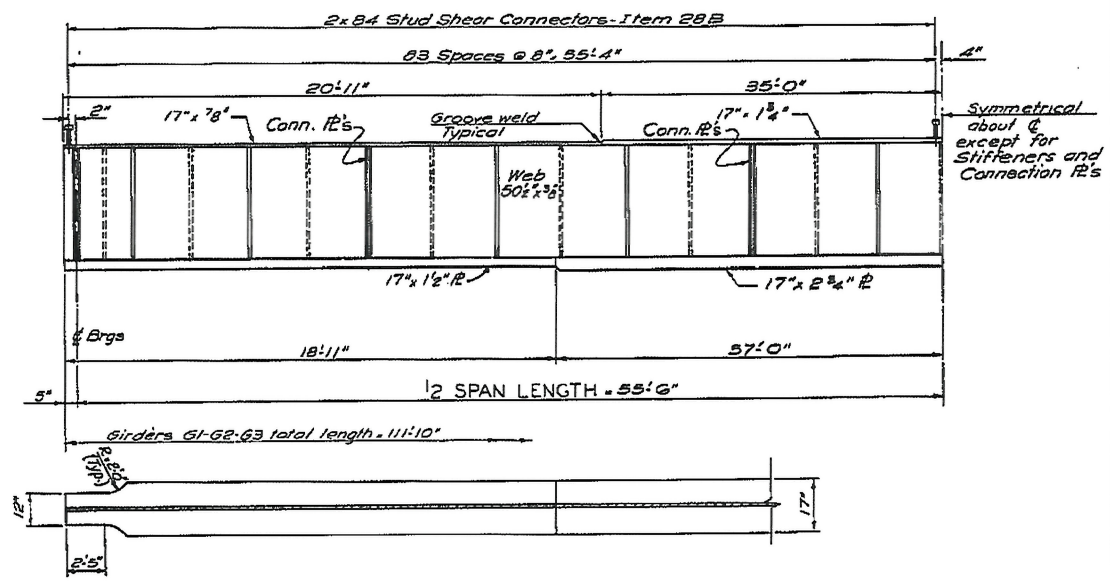
IMPACT DAMAGE PLAN

The steel showed signs of deterioration. The paint system is failing over 75% of the structure and bare steel was exposed. The fascia girders appeared to be in the worst condition with section loss in the web and bottom flanges throughout the length of the girders. All of the girders exhibited impact damage to the bottom flange over the NYS 290 Westbound lane. The damage includes dents and scrapes to the bottom flange.

△ - IMPACT DAMAGE
○ - PAINT SCRAPE ONLY FROM VEHICLE

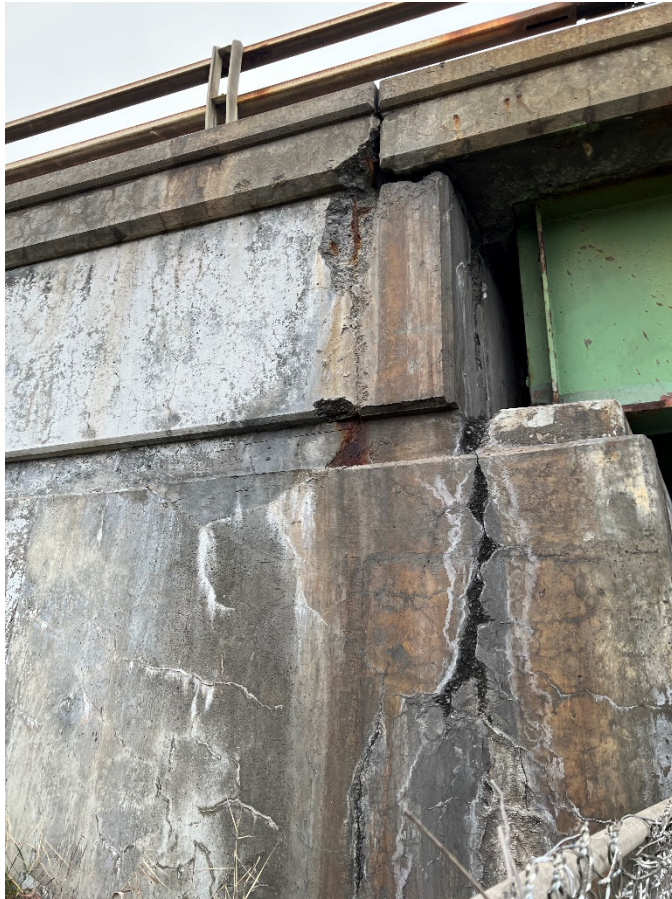
PHOTO 1

DESCRIPTION: BEGIN ABUTMENT– LEFT WINGWALL
SPALLING AND MAPCRACKING

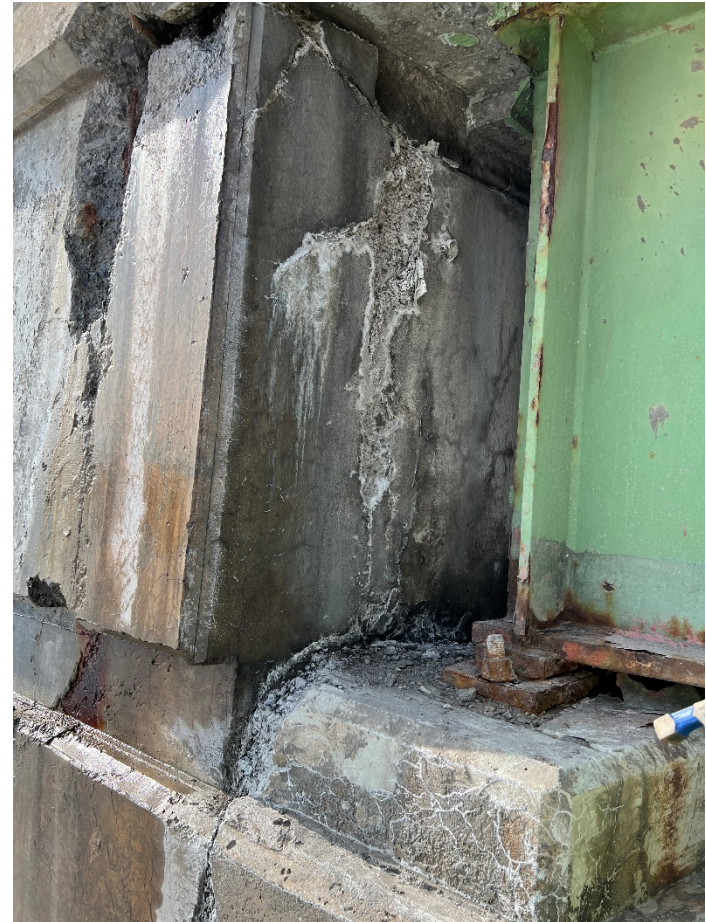
PHOTO 2

DESCRIPTION: BEGIN ABUTMENT – LEFT WINGWALL
SPALL AND BACKWALL SPALL

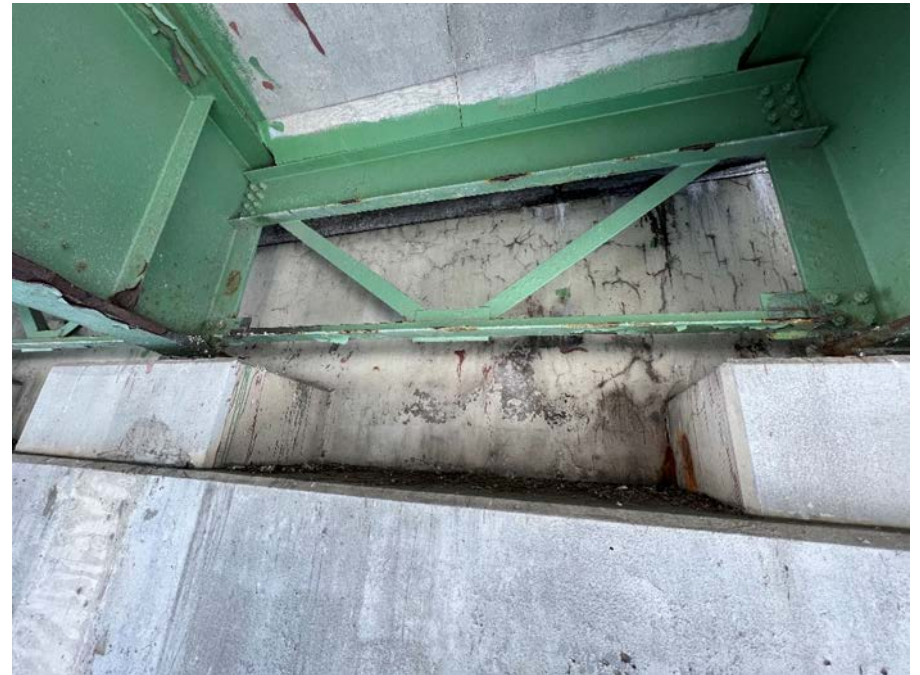
PHOTO 4

DESCRIPTION: BEGIN ABUTMENT – BAY 2 – BACKWALL
BETWEEN PEDESTAL 3 AND PEDESTAL 2 –
MAPCRACKING

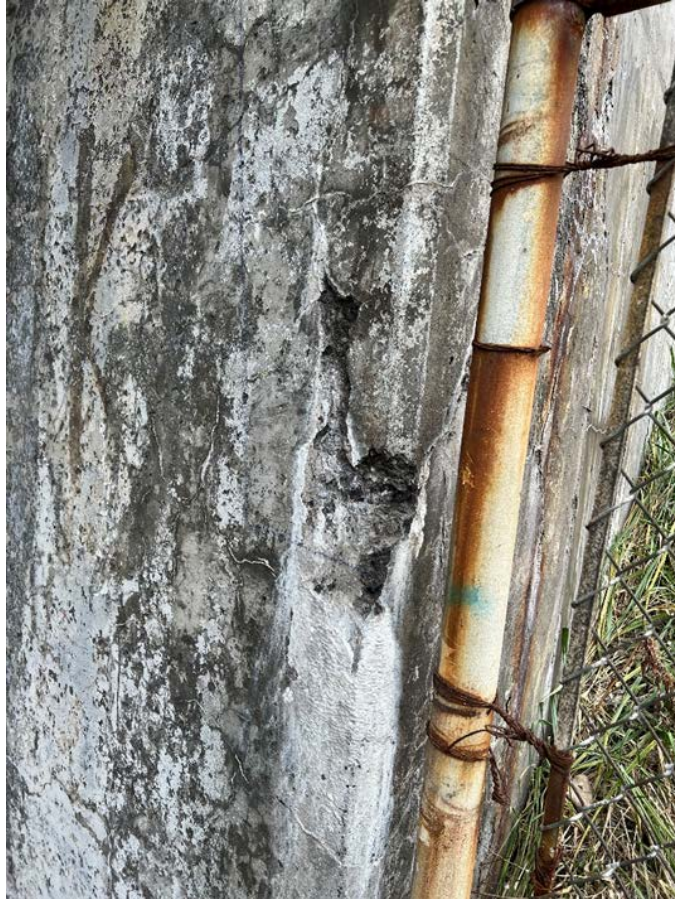
PHOTO 5

DESCRIPTION: BEGIN ABUTMENT – ABUTMENT SPALL AND SCALING

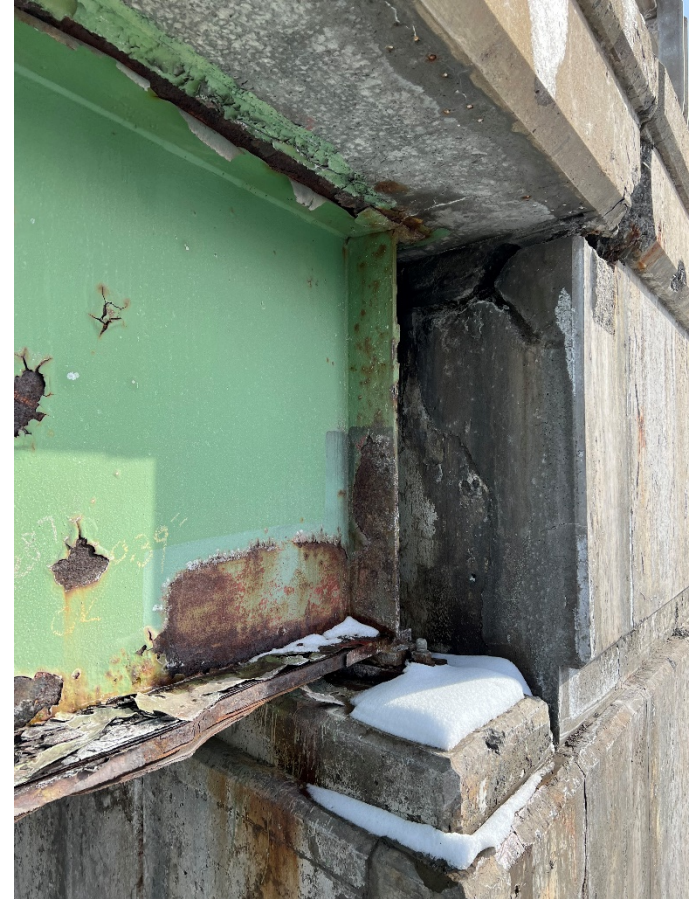
PHOTO 6

DESCRIPTION: BEGIN ABUTMENT – PEDESTAL 6 VIEW – GIRDER PAINT CONDITION, DELAMINATION OF BACKWALL

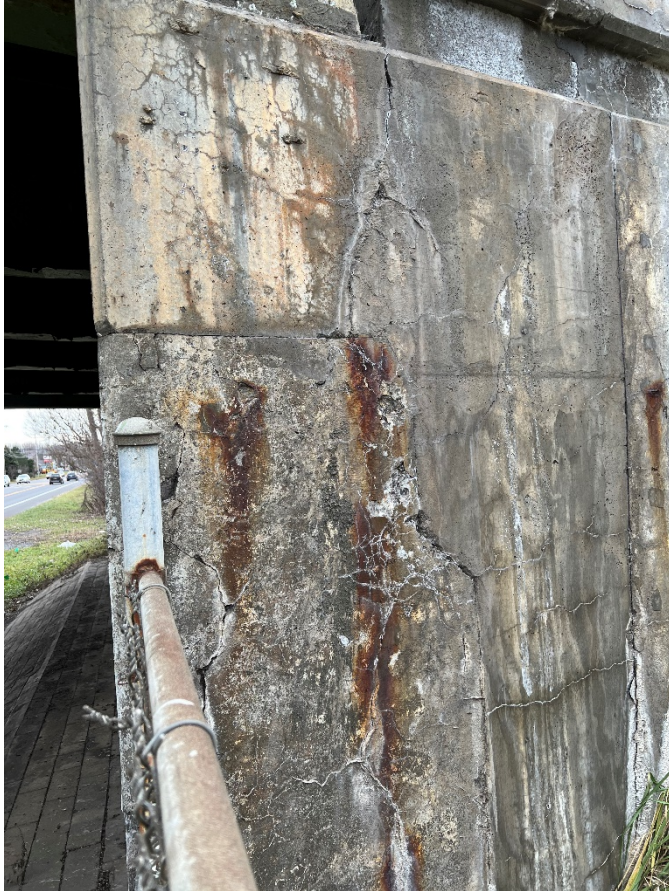
PHOTO 7

DESCRIPTION: BEGIN ABUTMENT – LOWER RIGHT WINGWALL REPAIR PATCH, MAP CRACKING AND RUST STAINING

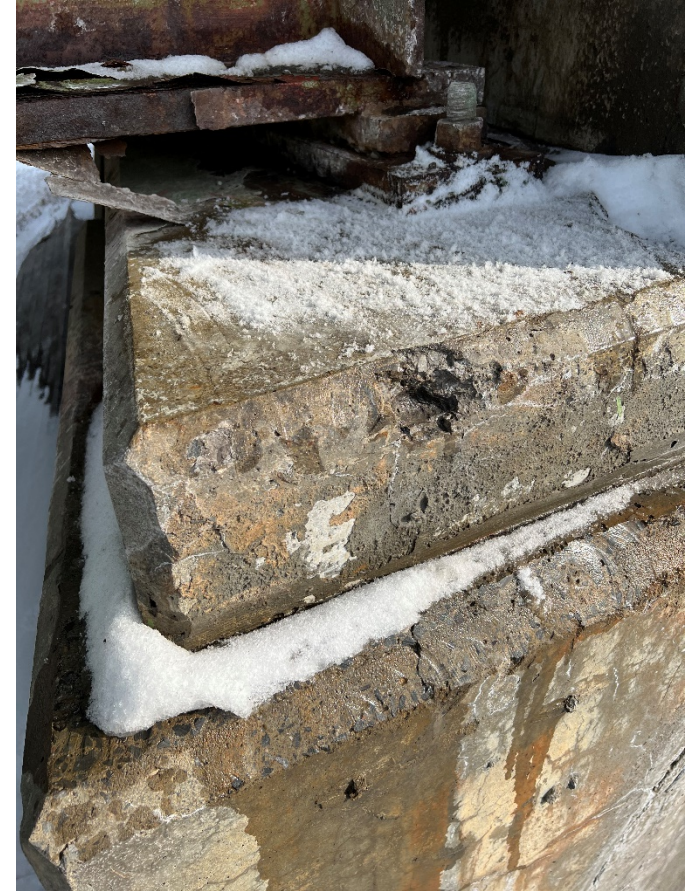
PHOTO 8

DESCRIPTION: BEGIN ABUTMENT – PEDESTAL 6 SPALL

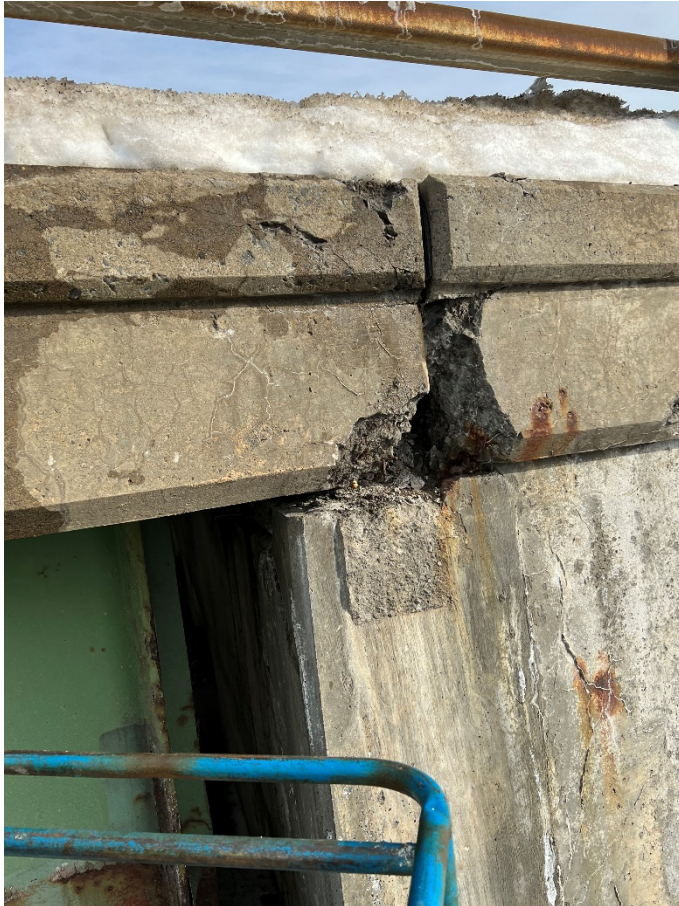
PHOTO 9

DESCRIPTION: BEGIN – BRIDGE OVERHANG – SPALL IN JOINT

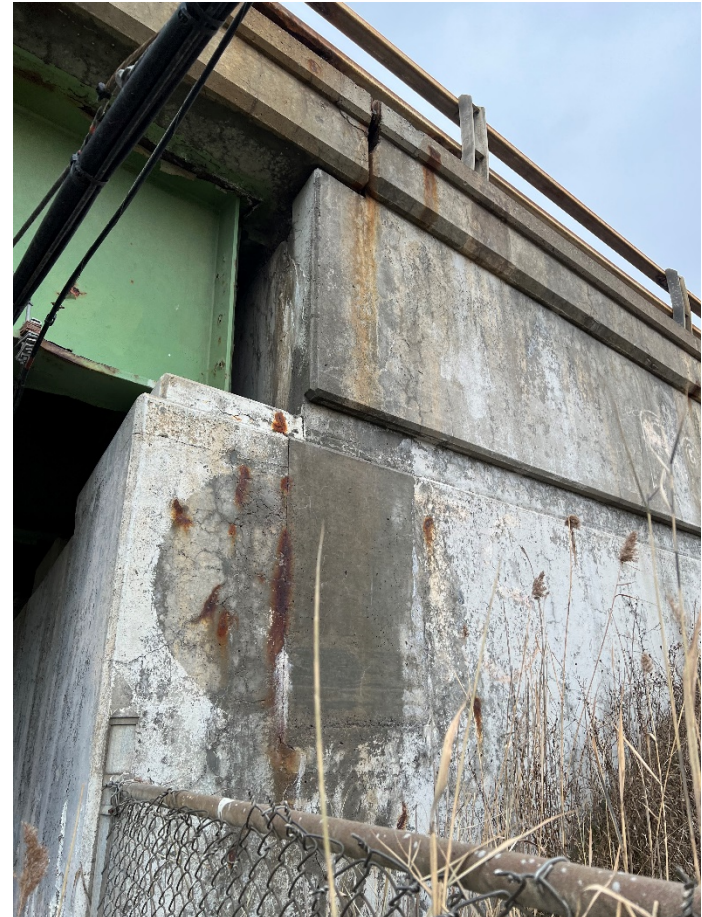
PHOTO 10

DESCRIPTION: END ABUTMENT – LOWER RIGHT WINGWALL REPAIR PATCH, MAP CRACKING AND RUST STAINING

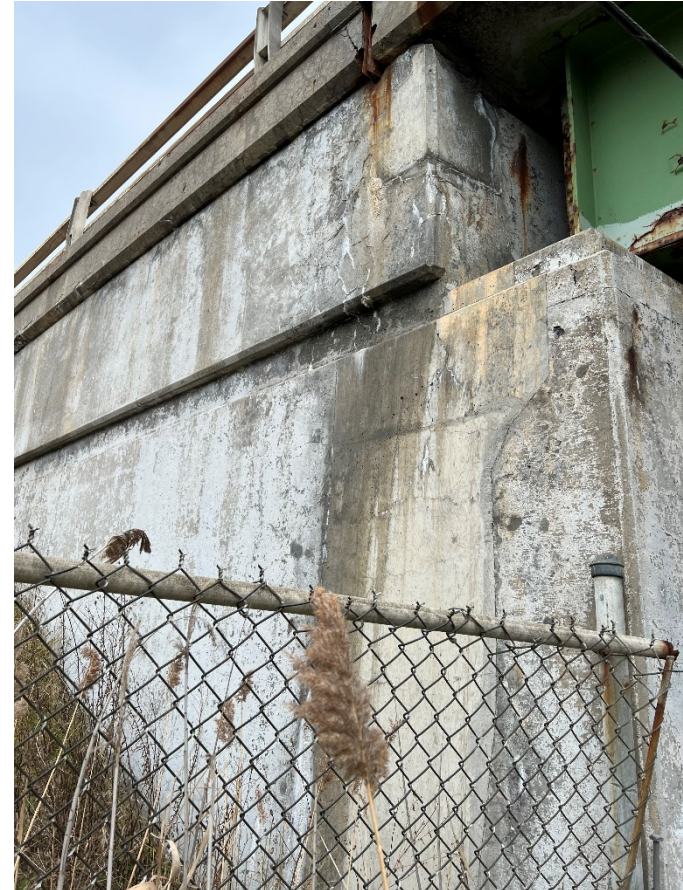
PHOTO 12

DESCRIPTION: END ABUTMENT – LEFT WINGWALL
REPAIR PATCHES, MAPCRACKING

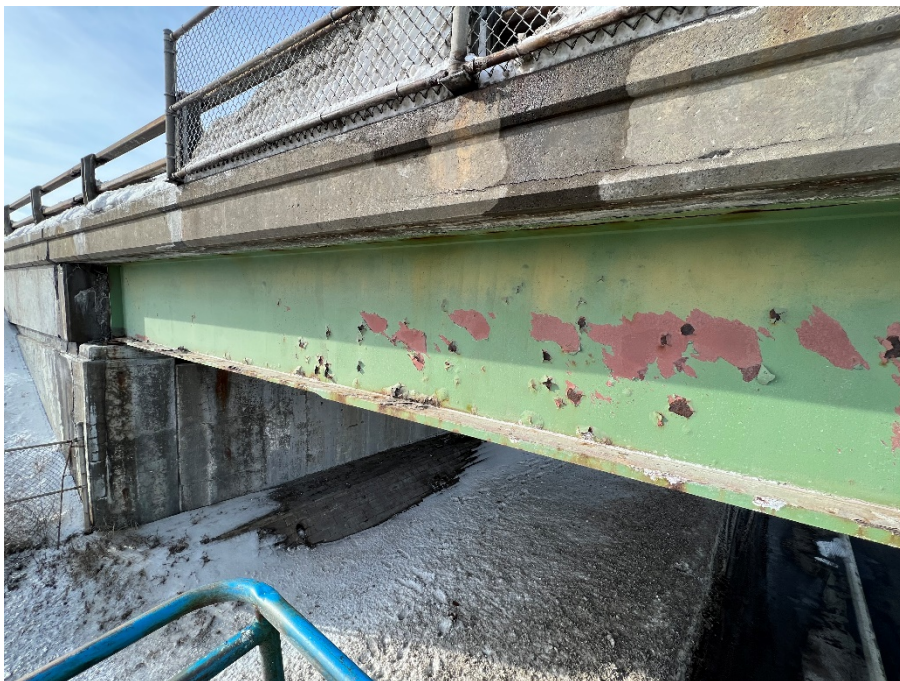
PHOTO 13

DESCRIPTION: FASCIA – GENERAL VIEW – PAINT
CONDITION, CRACK ALONG CONCRETE
OVERHANG

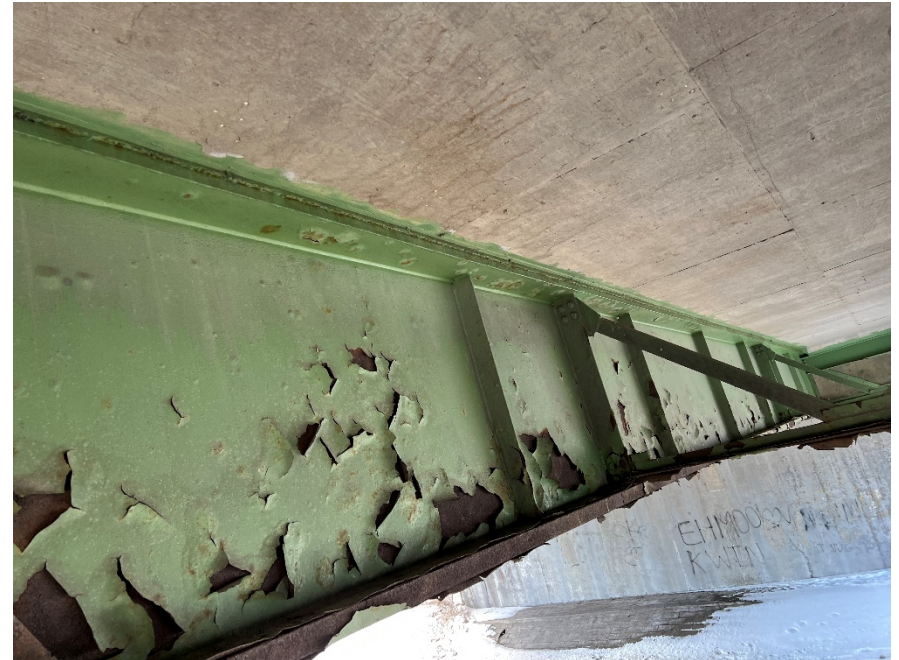
PHOTO 16

DESCRIPTION: BAY 1 – GIRDER 2 – UNDERSIDE
BRIDGE DECK FINE MAPCRACKING

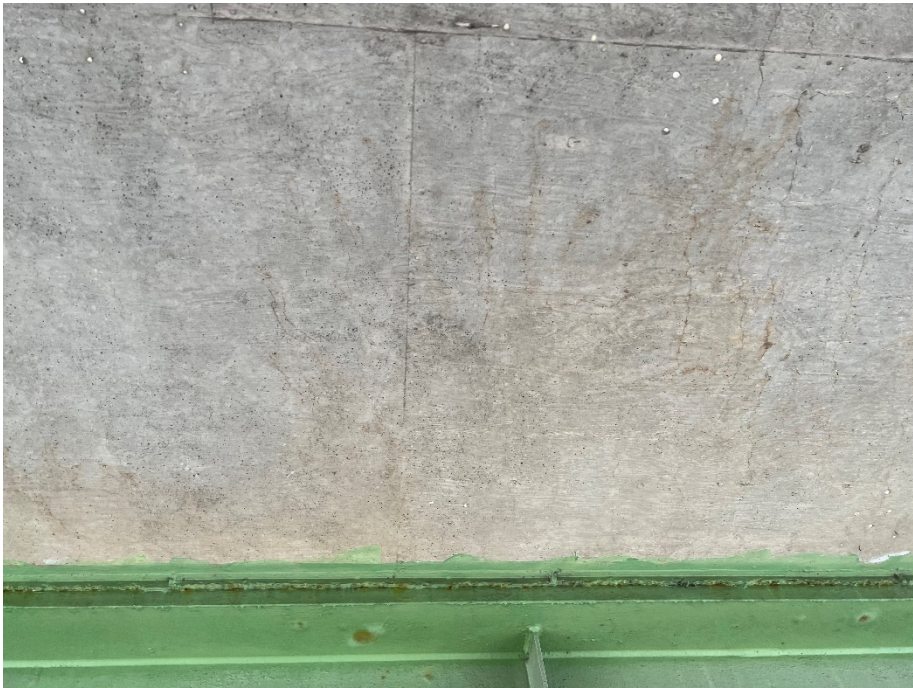
PHOTO 17

DESCRIPTION: BAY 2 – UNDERSIDE BRIDGE DECK –
FINE MAPCRACKING

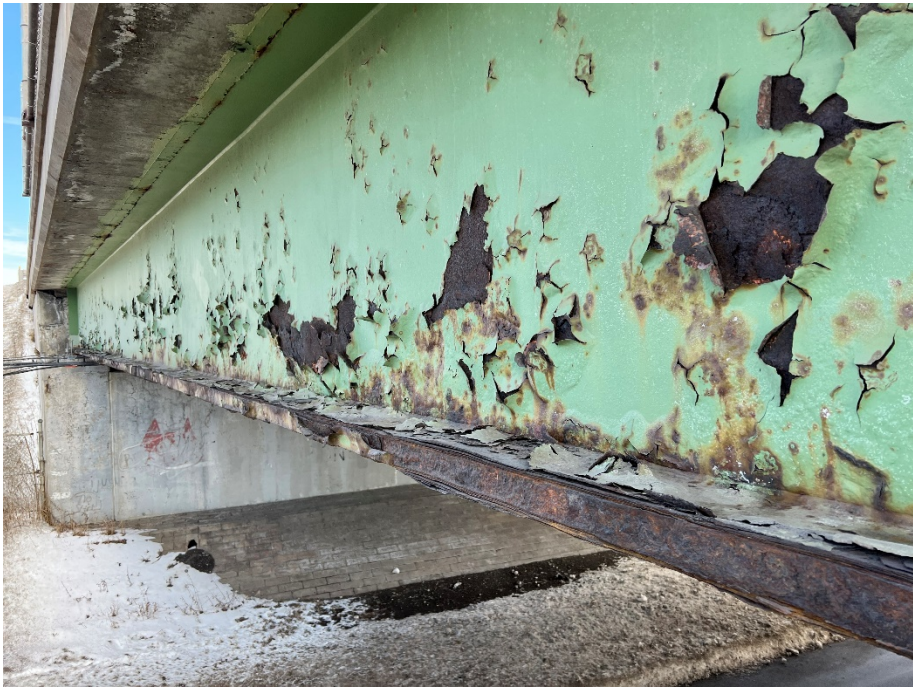
PHOTO 18

DESCRIPTION: FASCIA – FLAKING PAINT – UNDERSIDE
BRIDGE OVERHANG STAINING

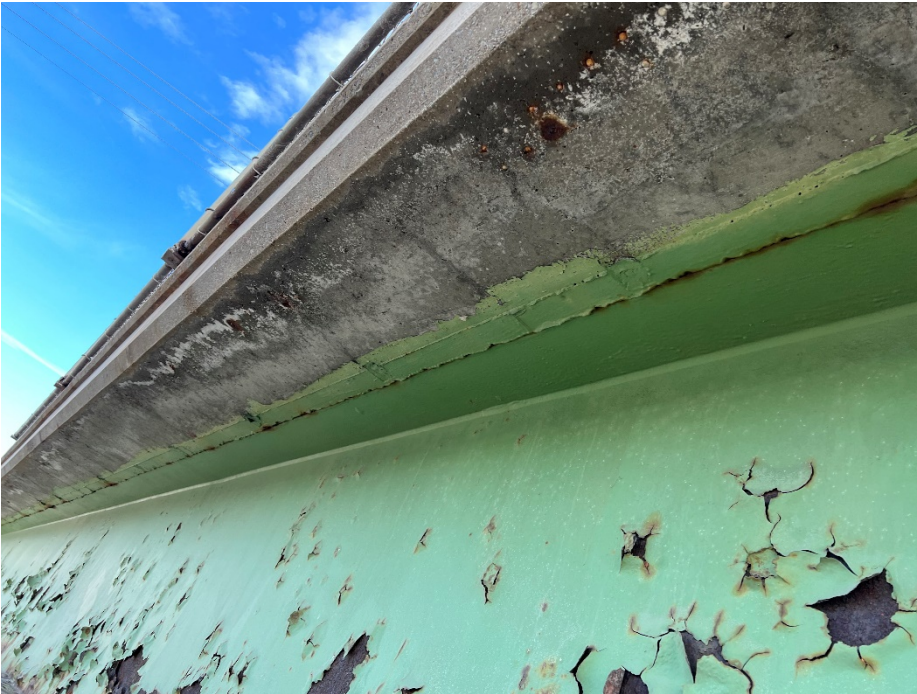
PHOTO 19

DESCRIPTION: UNDERSIDE OVERHANG CONCRETE STAINING

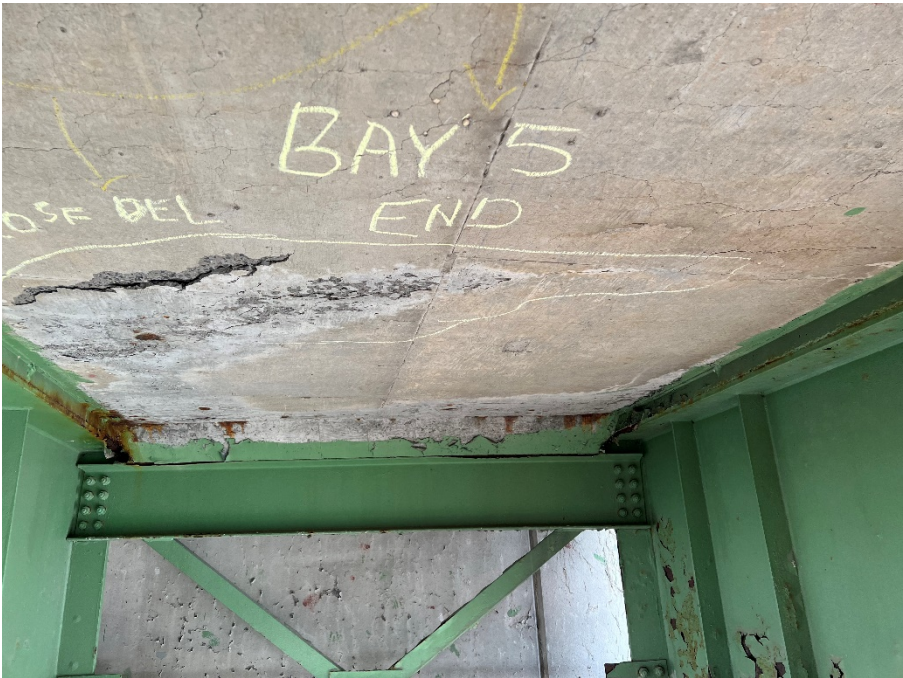
PHOTO 22

DESCRIPTION: BAY 5 – END ABUTMENT – UNDERSIDE
BRIDGE DECK DELAMINATION

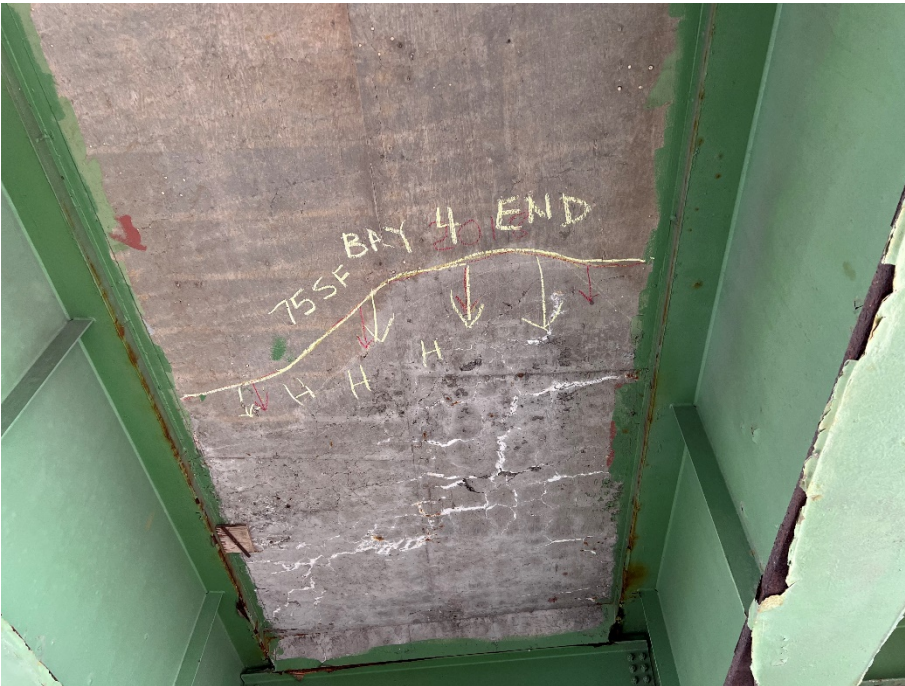
PHOTO 23

DESCRIPTION: BAY 4 – END ABUTMENT – UNDERSIDE
BRIDGE DECK MAPCRACKING AND
HOLLOW

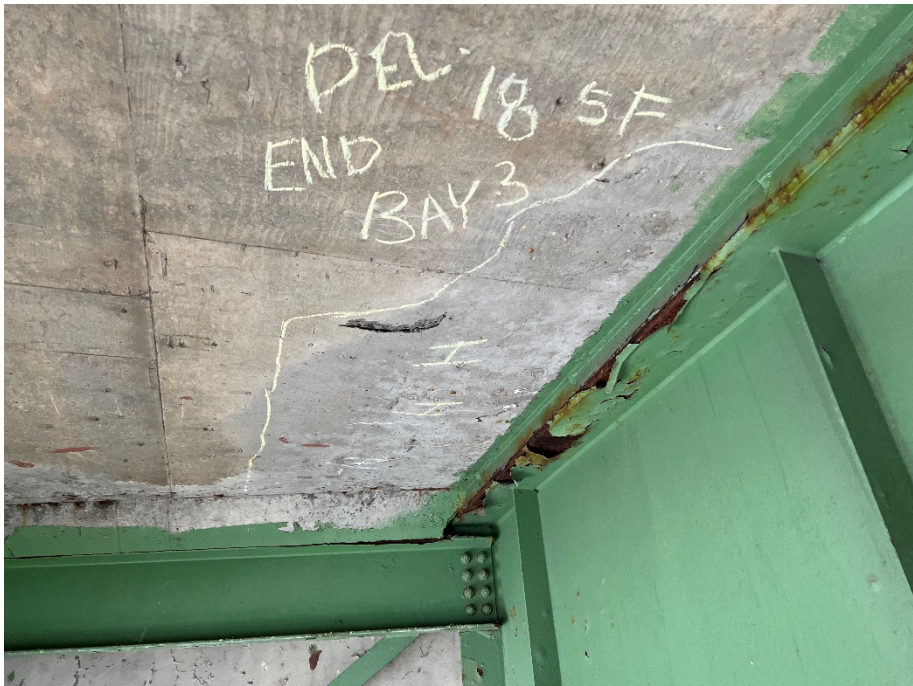
DESCRIPTION: BAY 3 END – UNDERSIDE BRIDGE DECK DELAMINATION

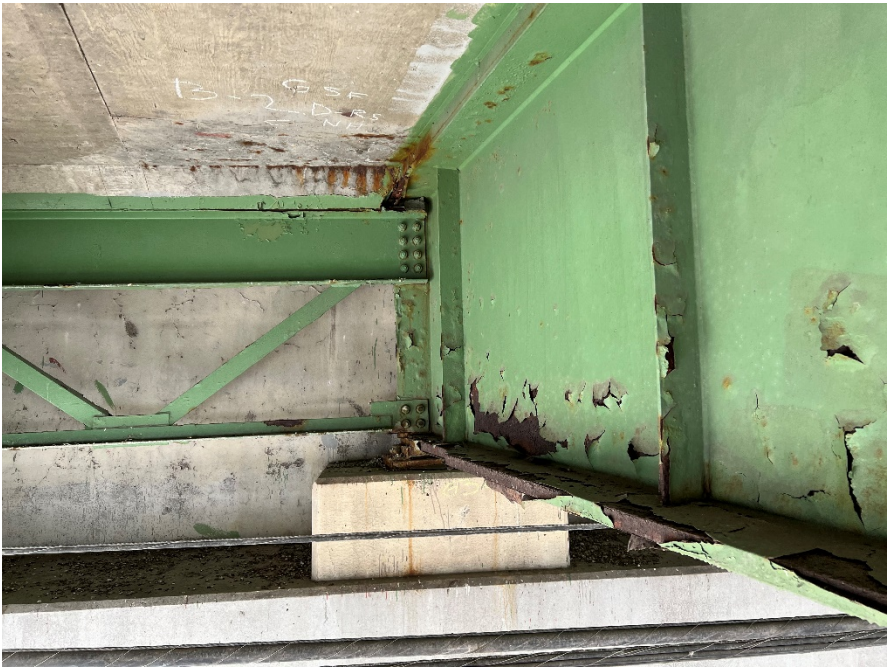
DESCRIPTION: BAY 2 END – UNDERSIDE DECK DELAMINATION

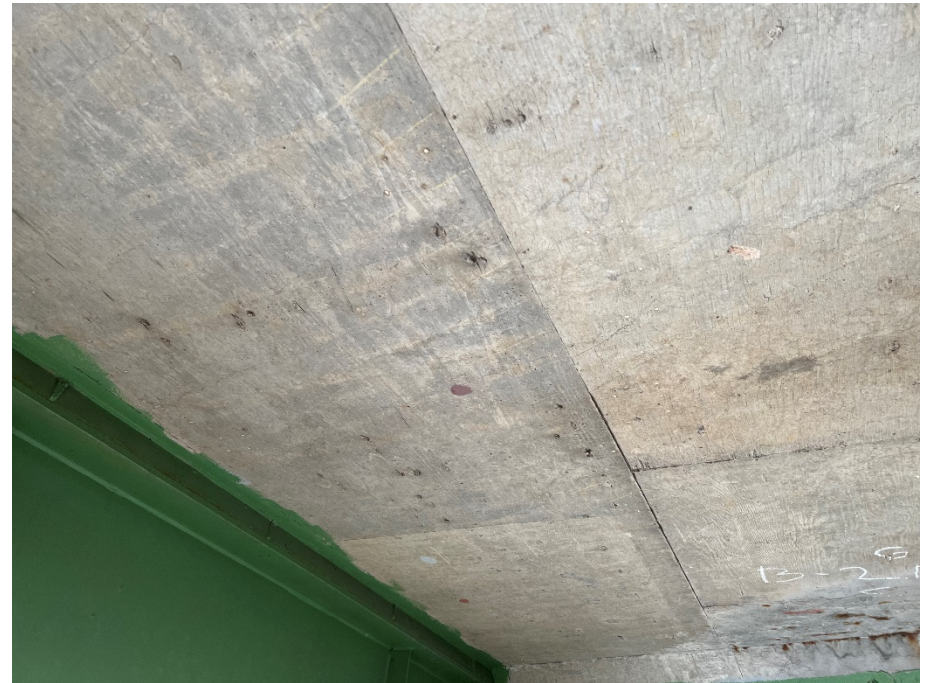
PHOTO 28

DESCRIPTION: BAY 2 END – UNDERSIDE DECK FINE
MAPCRACKING

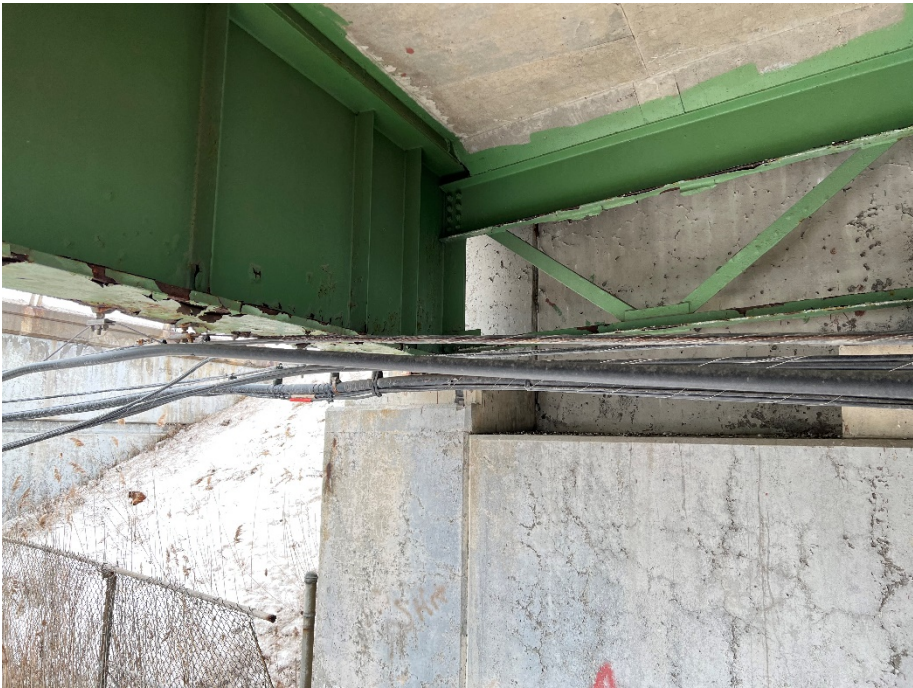
PHOTO 29

DESCRIPTION: BAY 1 END – ABUTMENT
MAPCRACKING, COMMUNICATION
LINES, BACKWALL

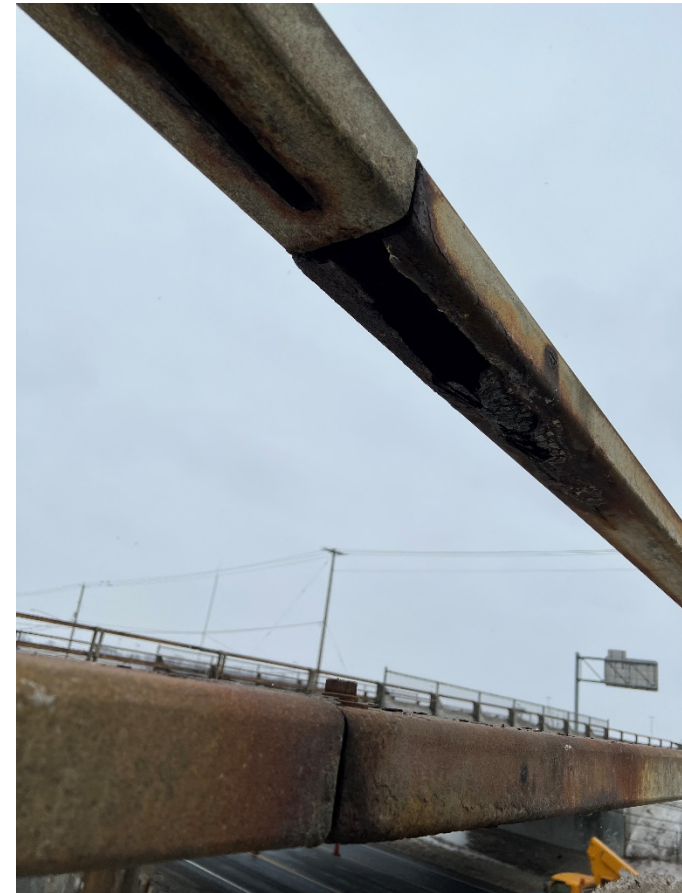
PHOTO 32

DESCRIPTION: BRIDGE DECK GUIDERAIL RUSTING OUT
